Fire Research Group
Department of Mechanical and Mechatronics Engineering
University of Waterloo
Waterloo ON Canada N2L 3G1
E. Weckman, A. Topic, T. Sheehan and G.Hitchman

MARITIME EVALUATION OF AEROSOL FIRE KNOCK DOWN TOOLS

PART 2: TOXICITY AND CORROSION POTENTIAL

DRDC DOCUMENT NUMBER: DRDC-RDDC-2014-C32

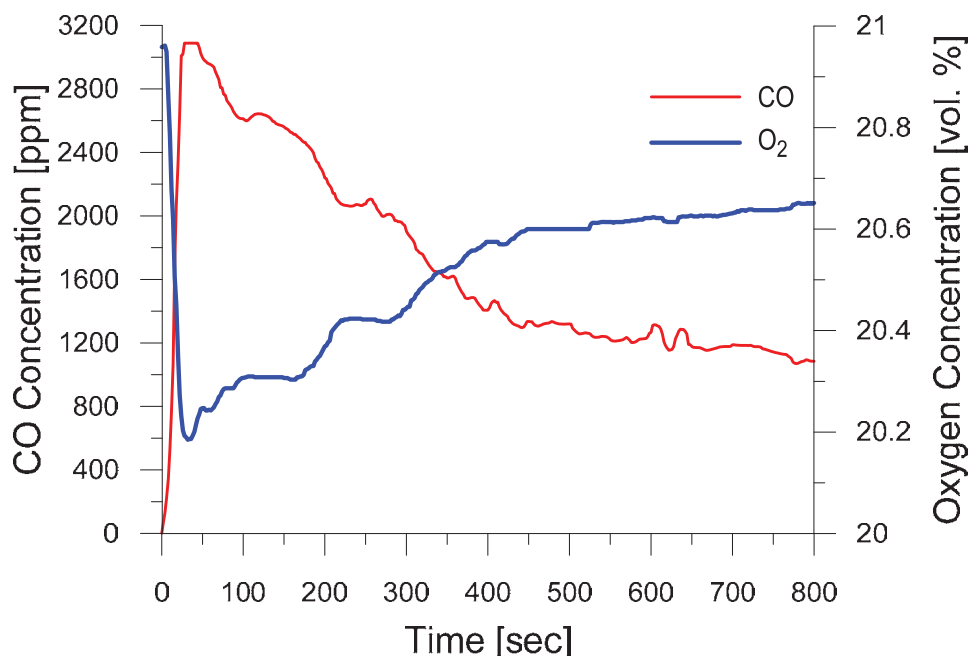
Figure 4-43: Measured CO concentrations during release of DSPA unit into a cold test compartment with no fire (Test 2)

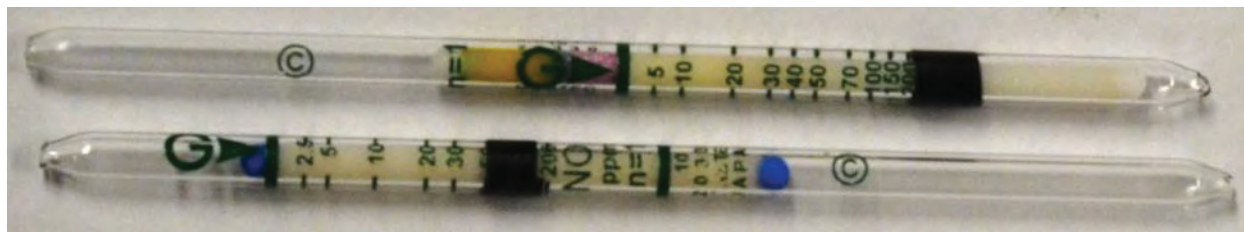
Figure 4-44: NOx concentrations measured using Gastec sampling tubes during release of a DSPA 5-4 unit into a cold test compartment with no fire (Test 2, 100 seconds)

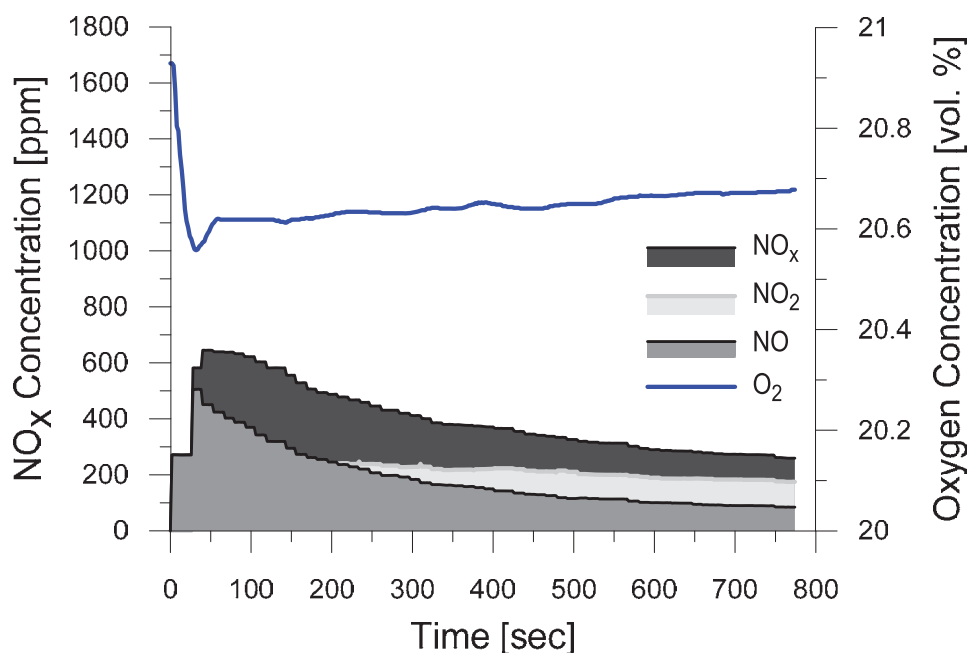
Figure 4-46: Measured NO_x concentrations during release of DSPA 5-4 unit into a cold test compartment with no fire (Test 3)

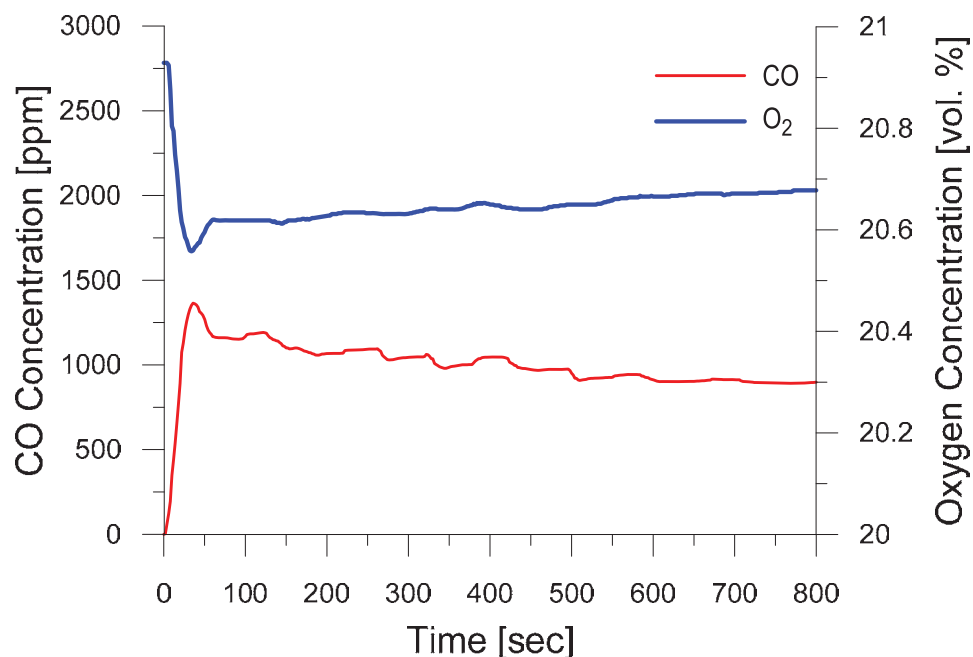
Figure 4-47: Measured CO concentrations during release of DSPA 5-4 unit into a cold test compartment with no fire (Test 3)

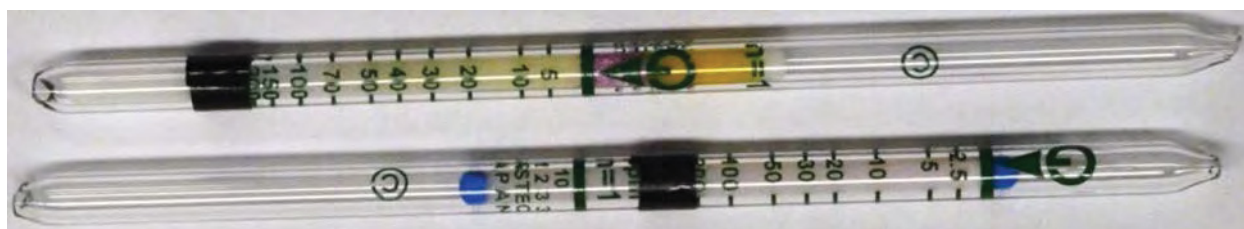
Figure 4-48: Measured NOx concentrations using Gastec sampling tubes during release of a DSPA 5-4 unit into a cold compartment with no fire (Test 3, 162 seconds)

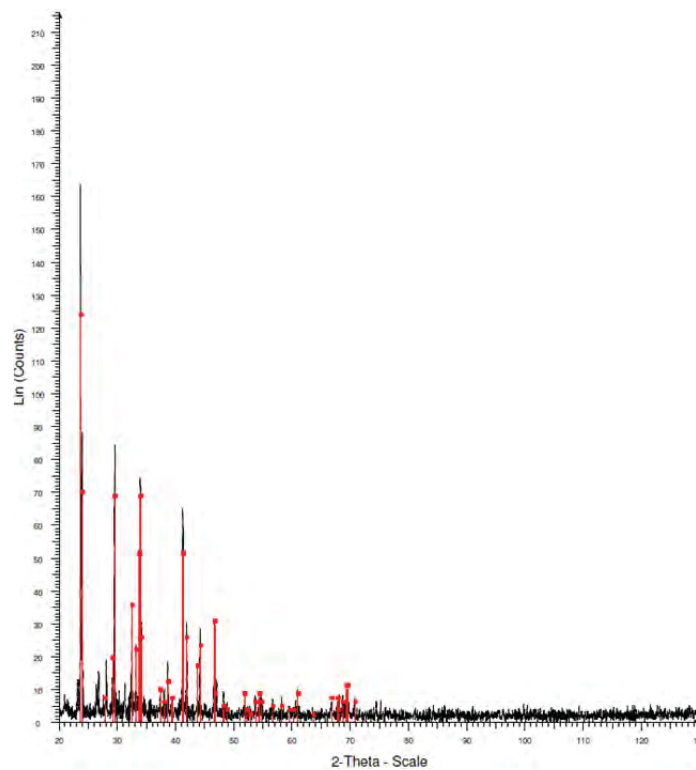
Figure 5-1: Diffractogram of raw StatX aerosol tablet

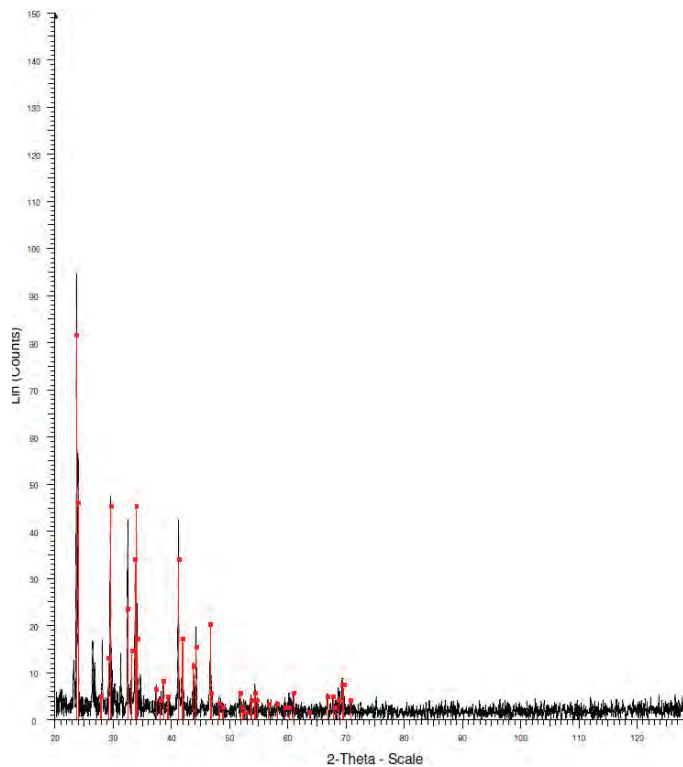
Figure 5-2: Diffractogram of the raw DSPA 5-4 aerosol agent

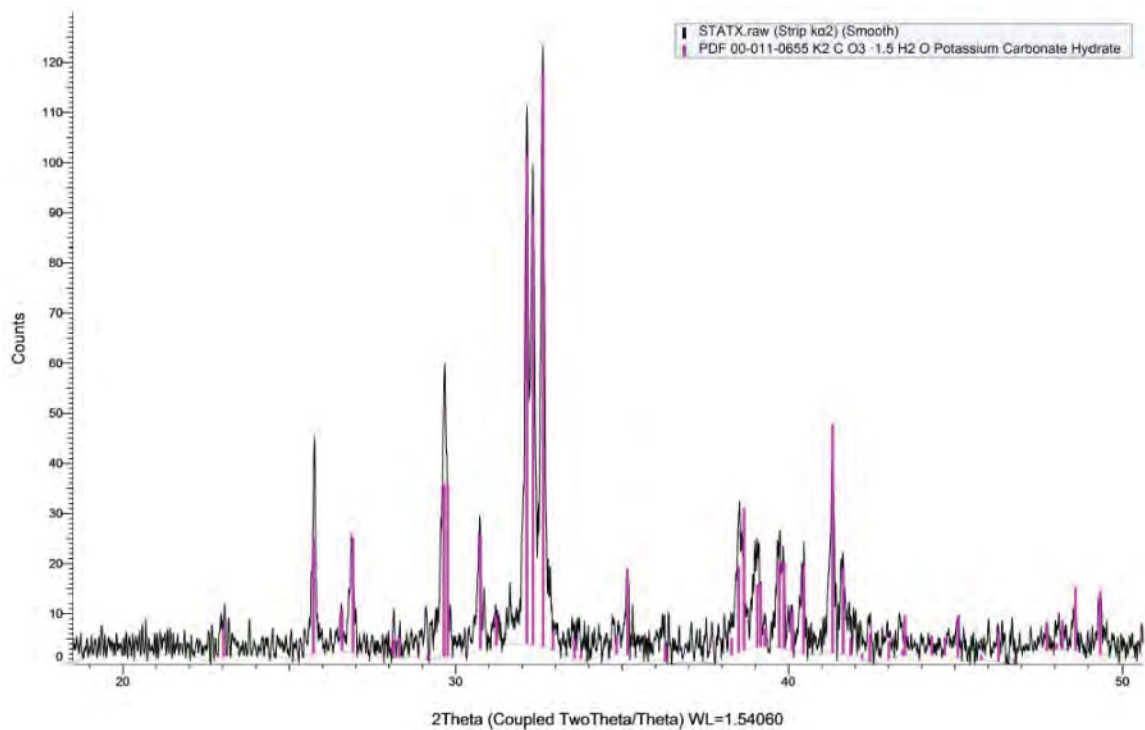
Figure 5-3: Diffractogram of the StatX aerosol extinguishing powder

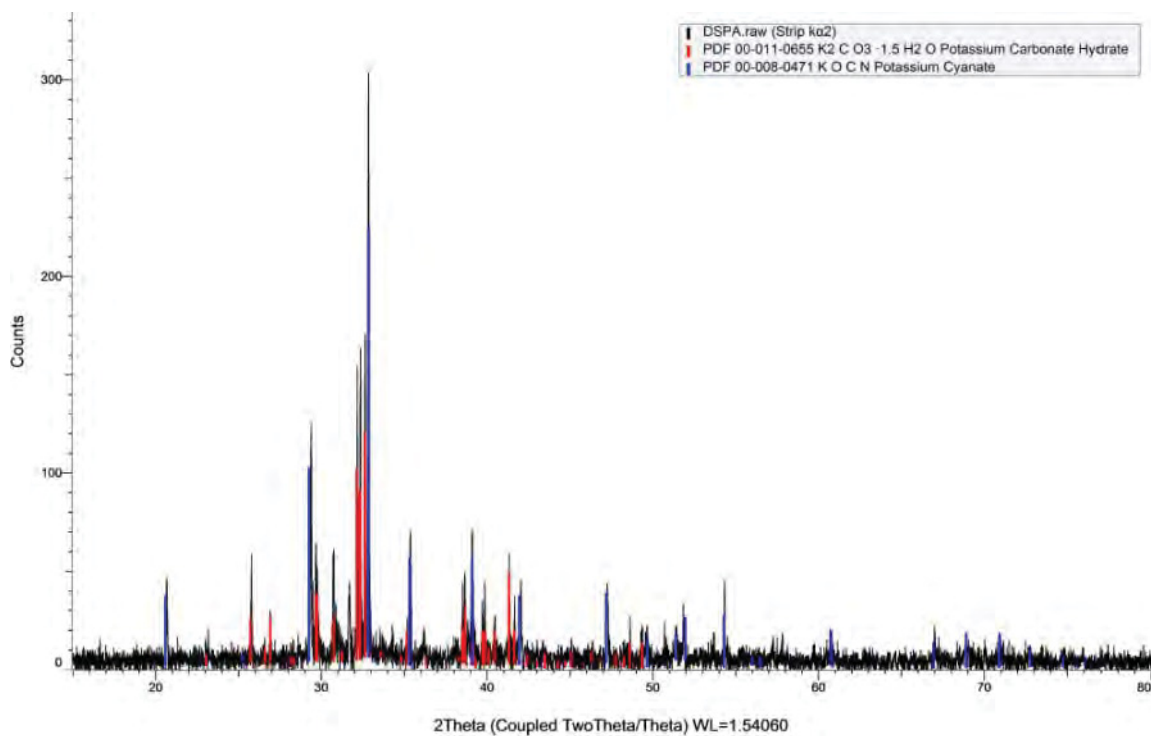
Figure 5-4: Diffractogram of the DSPA 5-4 aerosol extinguishing powder

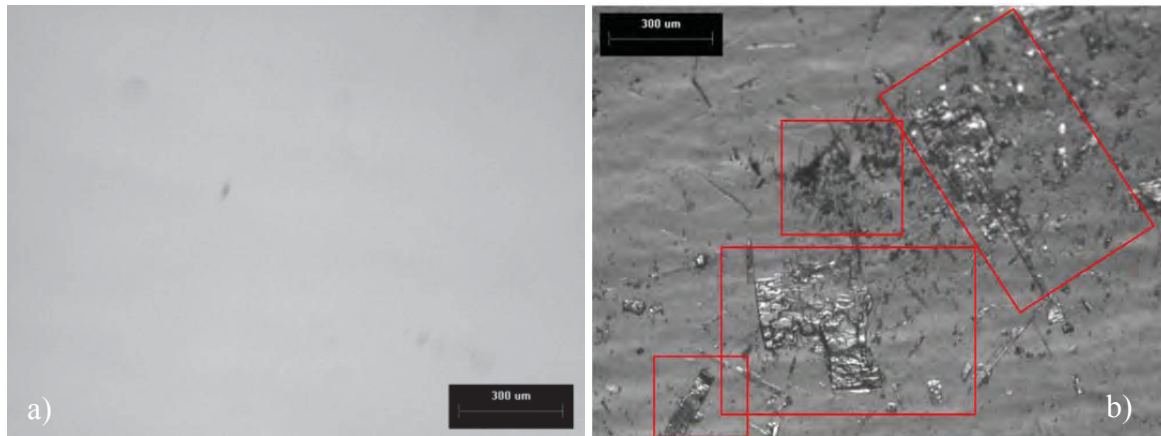
Figure 6-1: Surface of chrome plated aluminum sample (50x magnification) a) reference specimen b) six months after exposure to Stat X aerosol agent

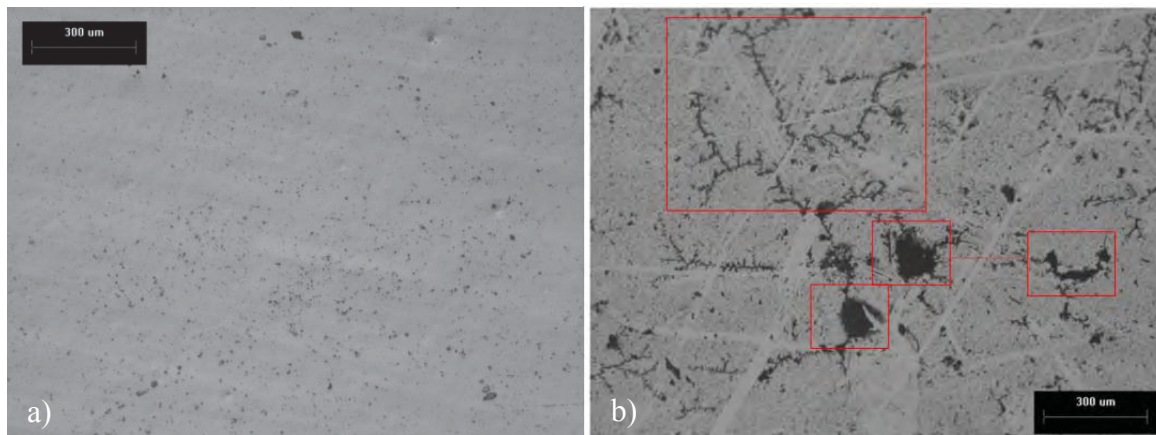
Figure 6-2: Surface of chrome plated aluminum sample (50X magnification) six months after exposure to a) diesel fire gases b) diesel fire gases and DSPA 5-4 aerosol agent

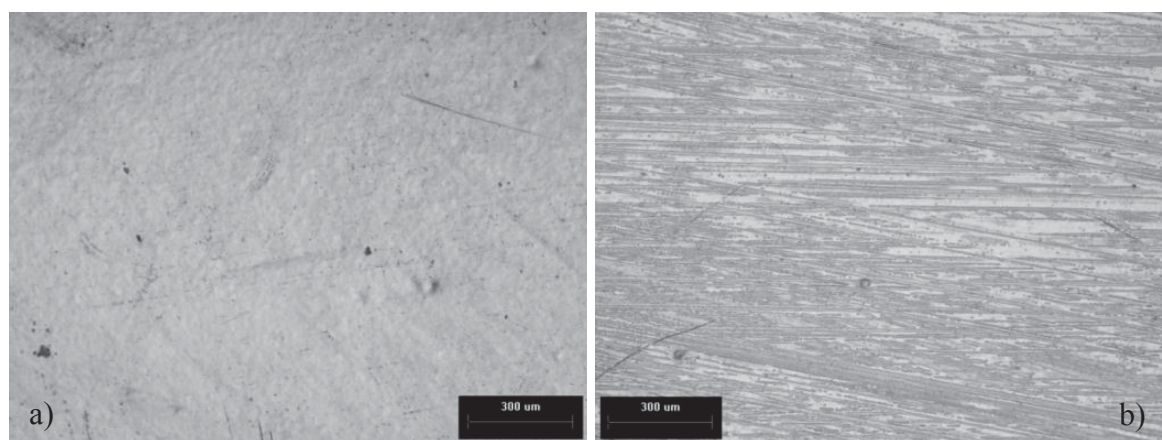
Figure 6-3: Surface of nickel plated aluminum sample (50x magnification) a) reference specimen b) six months after exposure to Stat X aerosol agent

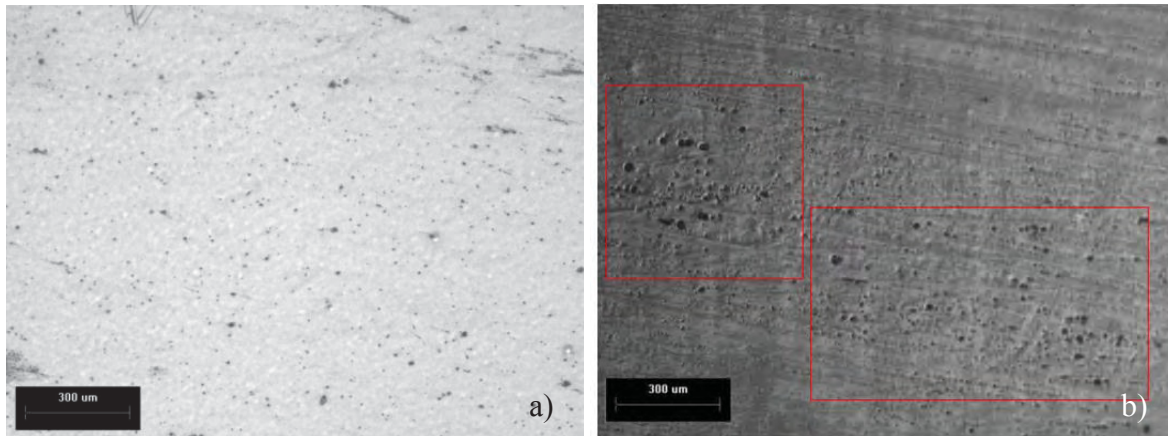
Figure 6-4: Surface of nickel plated aluminum sample (50X magnification) six months after exposure to a) diesel fire gases b) diesel fire gases and DSPA 5-4 aerosol agent

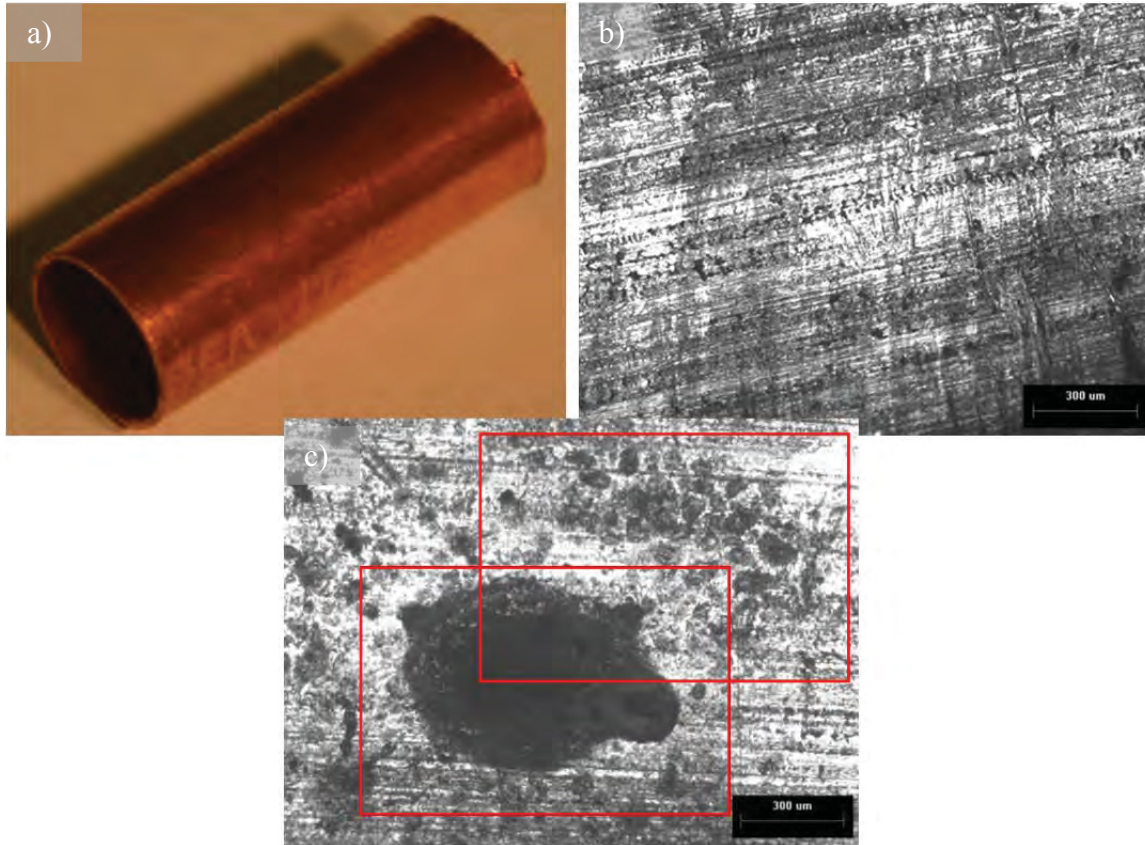
Figure 6-5: Surface of copper sample a) reference, no magnification b) reference, 50X magnification c) six months after exposure to aerosol, 50X magnification

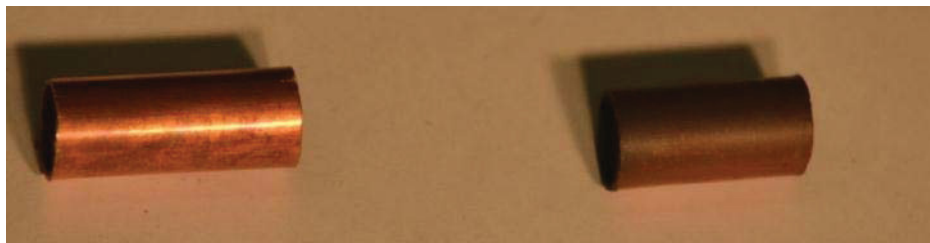
Figure 6-6 contains an image of the reference copper specimen (left) with that of a different sample taken six months after it was exposed to a combination of diesel fire gases and aerosol powder generated by the DSPA 5-4 unit during a diesel fire suppression test. Comparison of the images shows that there is notable discolouration of the copper, suggesting oxidation of the surface during exposure to the heat, diesel fire gases and aerosol agent generated during suppression.

Figure 6-6: Surface of control sample (left) and sample six months after exposure to the diesel fire gases with aerosol agent suppression (right) showing discolouration of surface

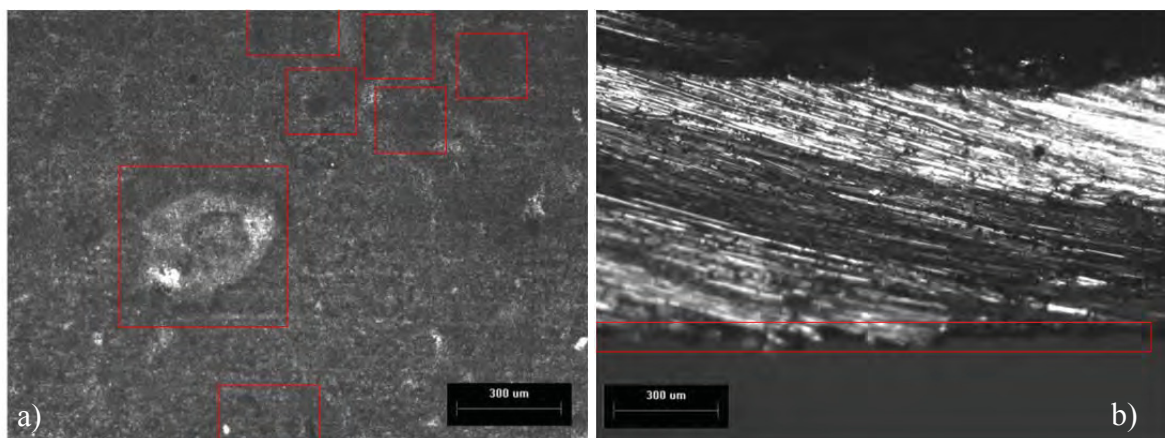
A magnified image of a section of the surface of the exposed copper sample is in Figure 6-7 a) with a cross-section through the same sample shown in Figure 6-7 b). Both images are taken at 50X magnification with a 300 μm scale in the bottom corners. Surface pitting caused by exposure to the diesel fire gases and aerosol suppression agent can be seen in Figure 6-7 a); however, the rough surface of the pipe makes it difficult to discern these pits in the cross-sectional sample, Figure 6-7 b). More evident in the cross-sectional image is a thin black layer on the outer edge of the surface along the length of the section. This layer appears to indicate surface oxidation;

Figure 6-7: Surface of copper sample (50X magnification) six months after exposure to diesel fire gases and DSPA 5-4 aerosol agent a) surface view b) cross-sectional view

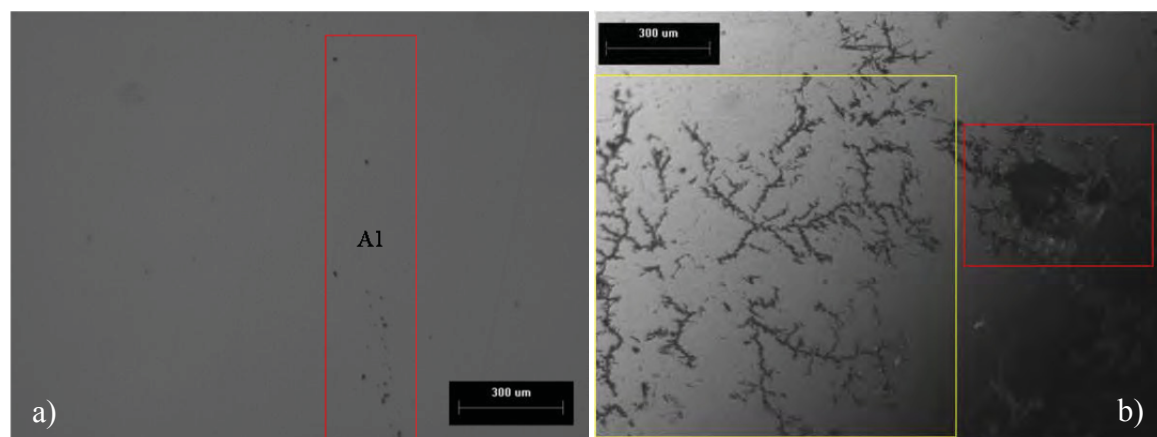
Figure 6-8: Surface of chrome plated steel sample (50X magnification) a) reference specimen b) six months after exposure to aerosol

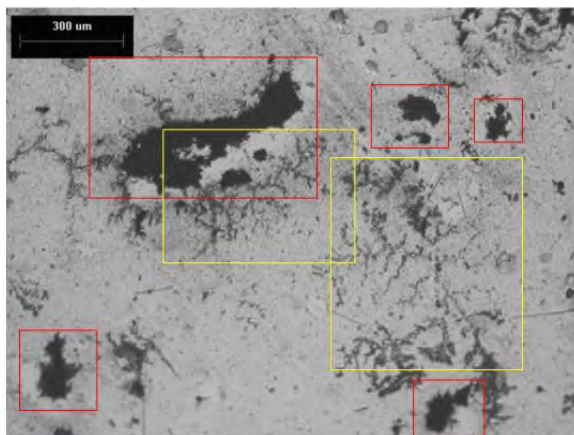
Figure 6-9: Chrome plated steel six months after exposure to the diesel fire gases with aerosol agent suppression (50x magnification)

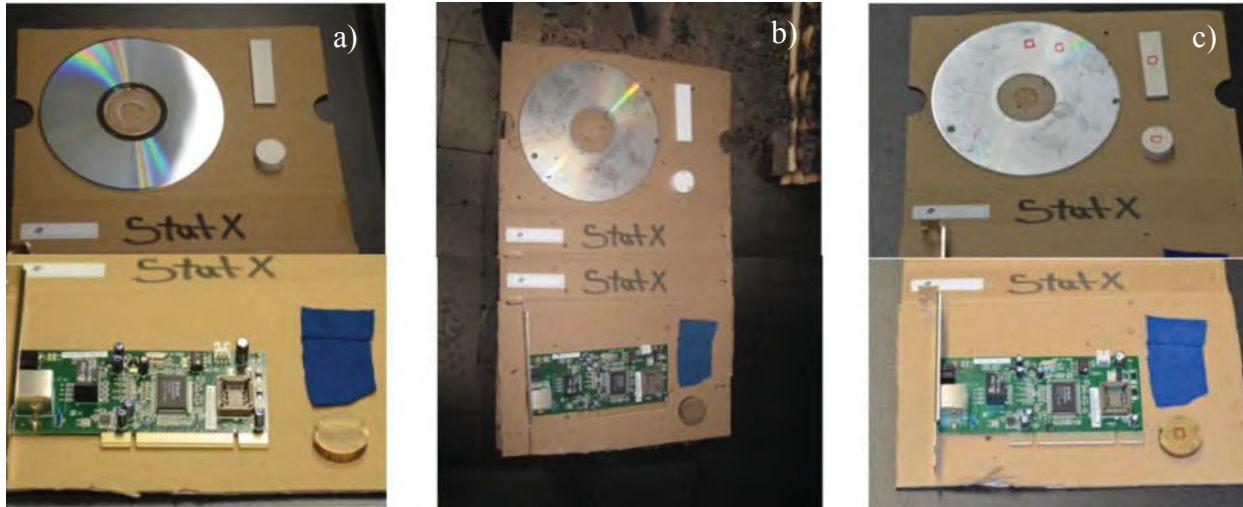
Figure 6-10: Nikon D7000 photographs of material samples used in StatX agent only test
a) reference specimens b) specimens immediately after exposure to aerosol
c) specimens one month after exposure to aerosol

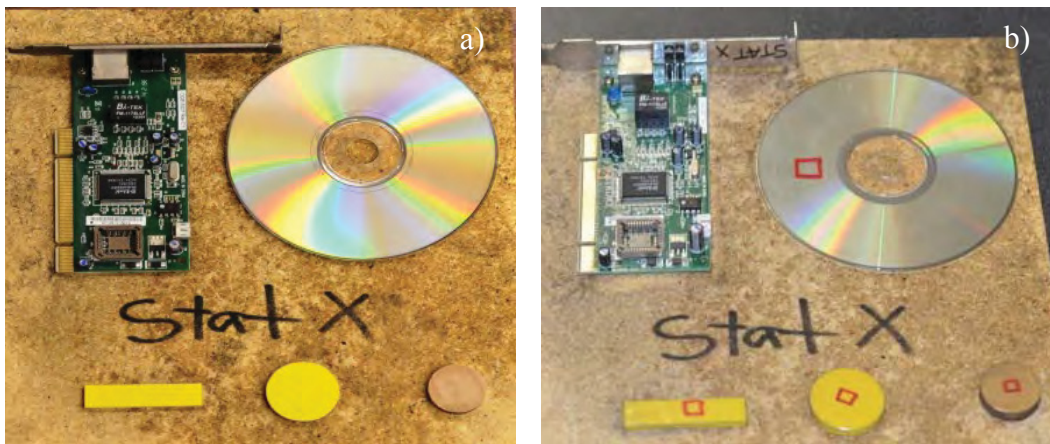
Figure 6-11: Nikon D7000 photographs of material samples in a StatX unobstructed fire suppression test
a) reference specimens b) specimens one month after exposure to aerosol

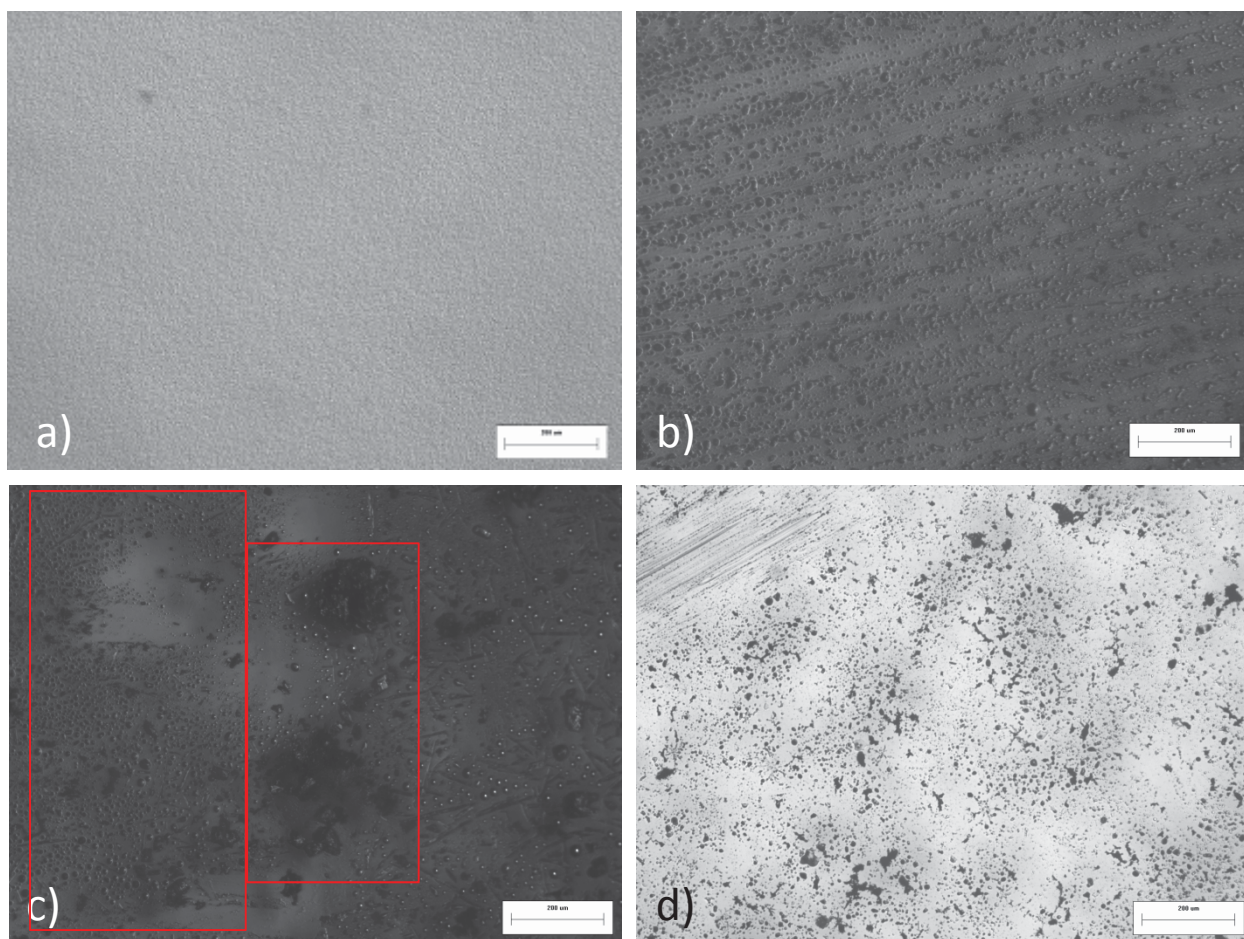
Figure 6-12: Surface of computer disc (50X magnification) a) reference specimen b) three months after exposure to StatX aerosol only (cleaned) c) three months after exposure to StatX aerosol only (uncleaned) and d) two months after exposure to diesel fire with StatX suppression

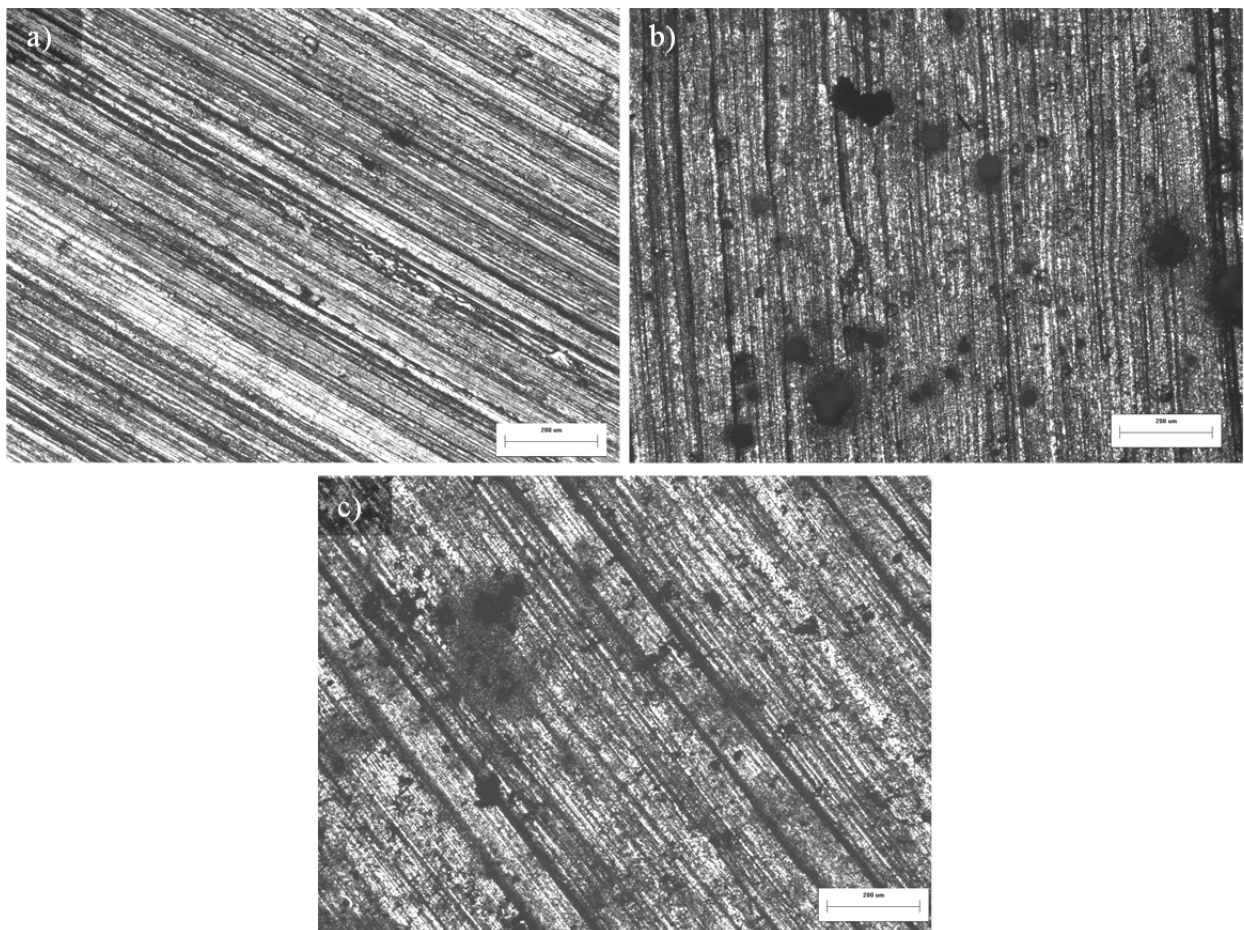
Figure 6-13: Surface of copper beryllium disc (50x magnification) a) reference specimen b) three months after exposure to StatX aerosol only c) two months after exposure to diesel fire with StatX suppression

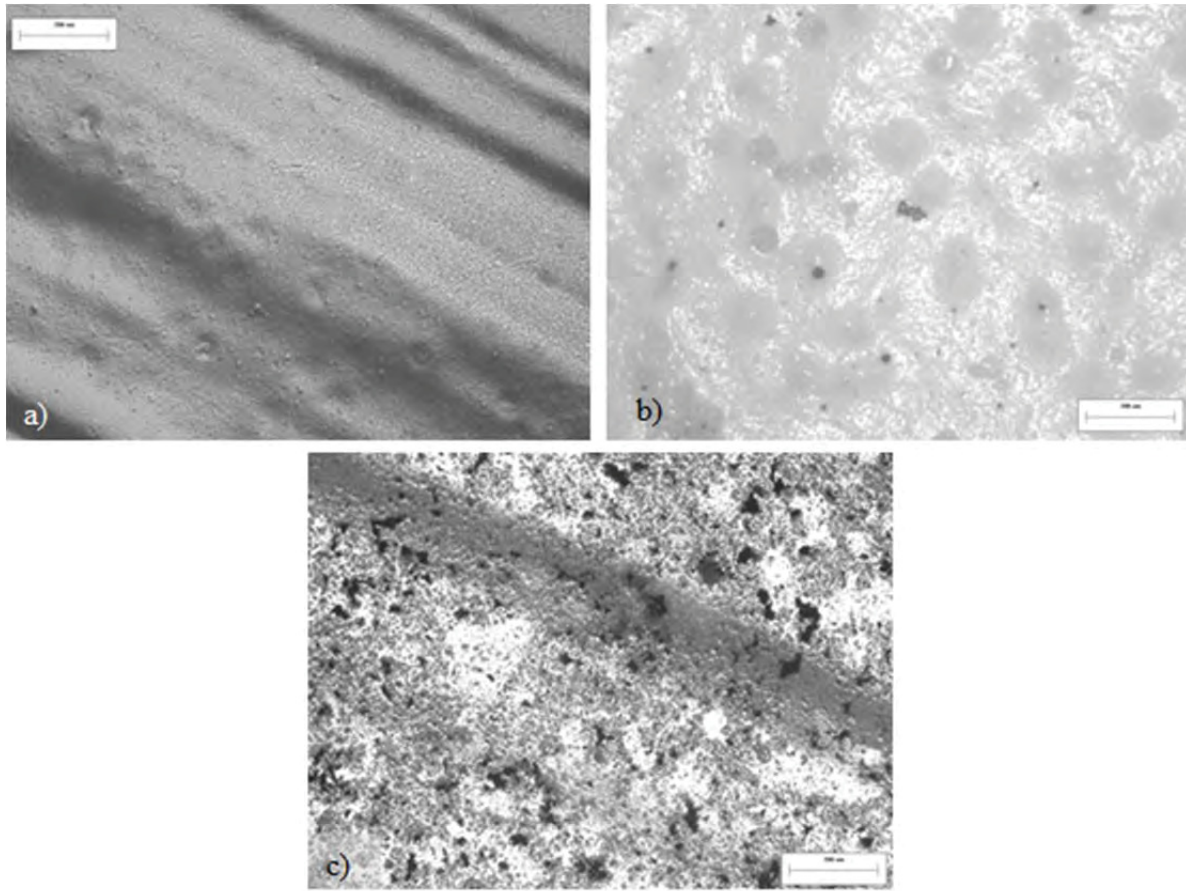
Figure 6-14: Surface of AISI 4140 high tensile steel specimen (50x magnification) a) reference specimen b) three months after exposure to StatX aerosol only and c) two months after exposure to diesel fire with StatX suppression

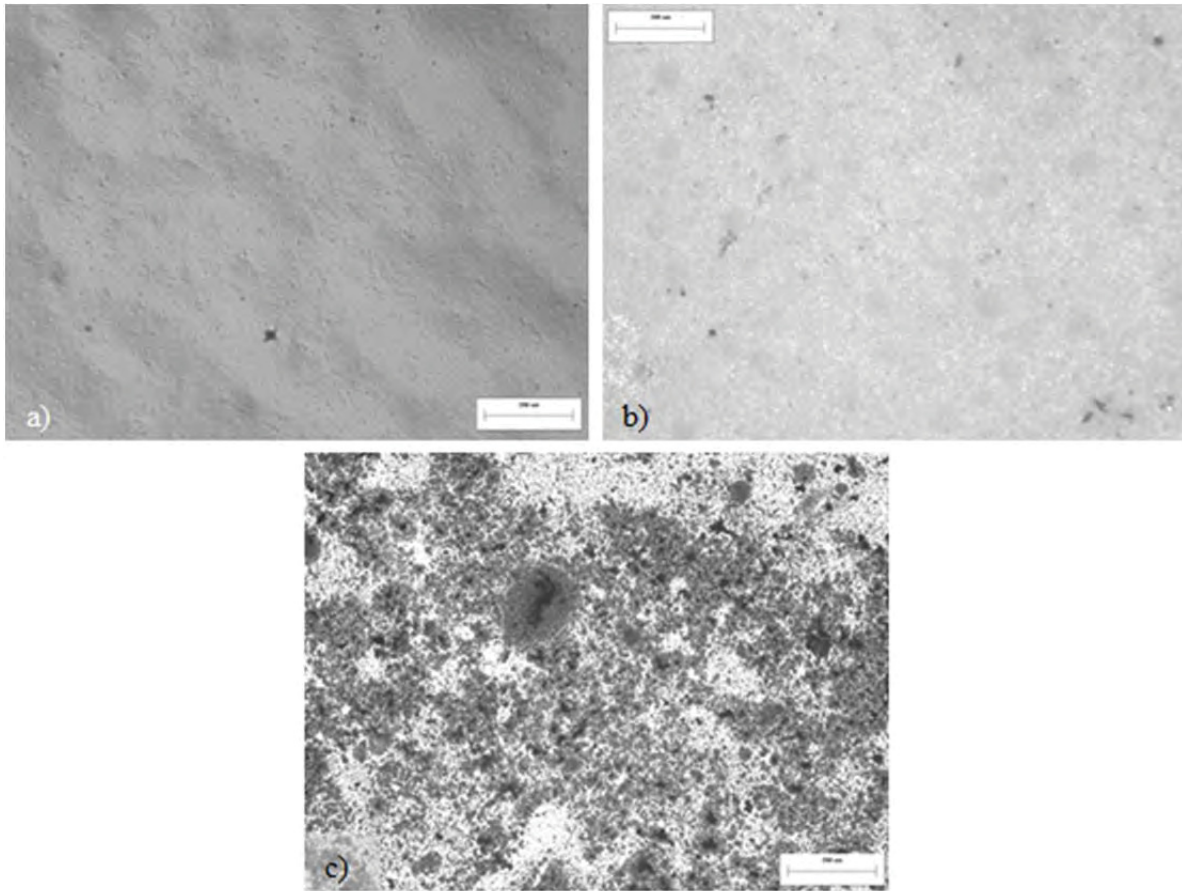
Figure 6-15: Surface of AISI 1018 mild steel specimen (50x magnification) a) reference specimen b) three months after exposure to StatX aerosol only and c) two months after exposure to diesel fire with StatX suppression

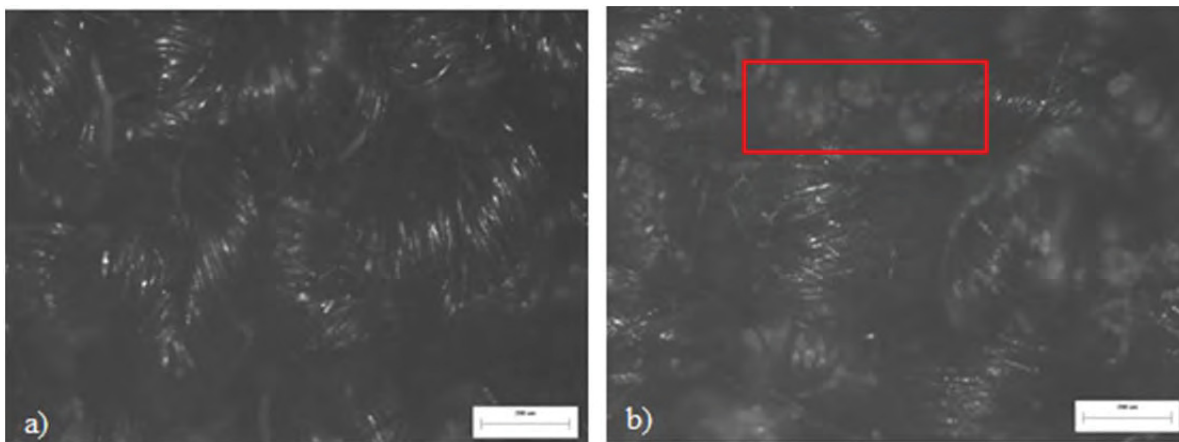
Figure 6-16: NOMEX fabric specimen (50x magnification) a) reference specimen and b) three months after exposure to StatX aerosol only

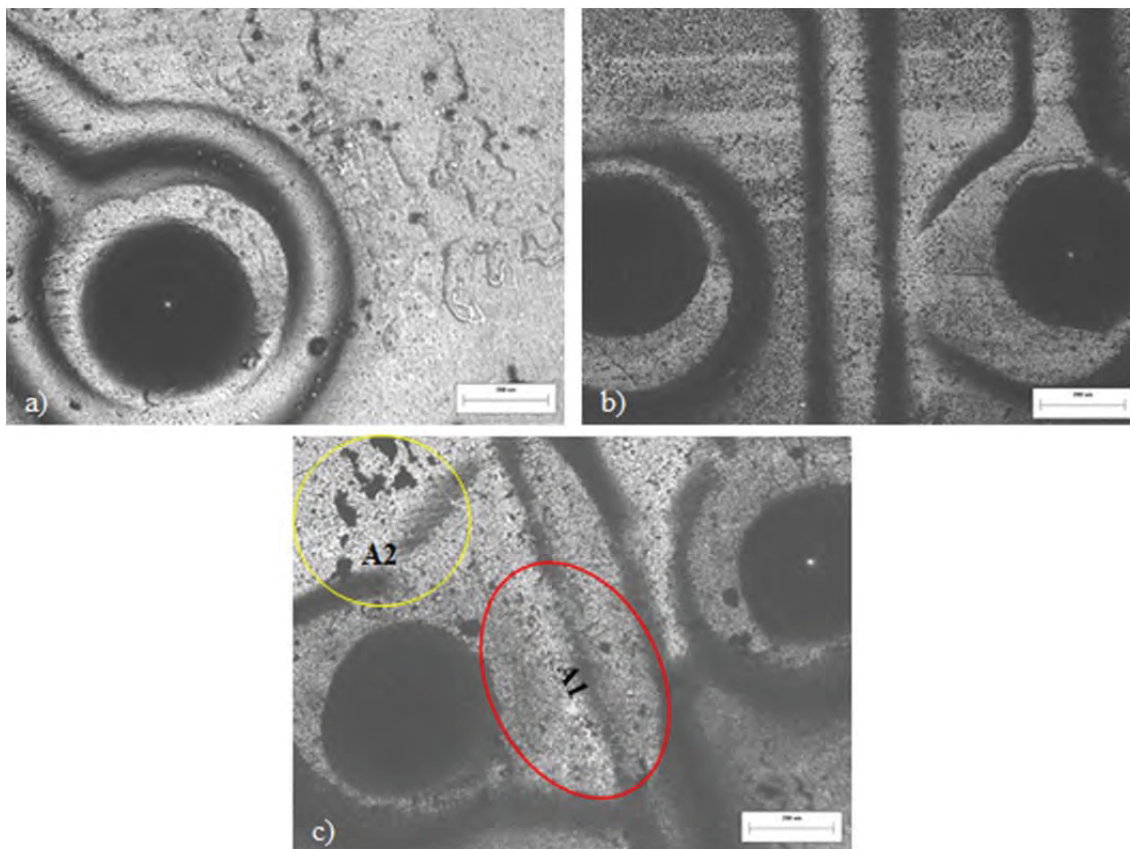
Figure 6-17: Connectors on computer circuit board (50X magnification) a) reference specimen b) three months after exposure to StatX aerosol only c) two months after exposure to diesel fire with StatX suppression

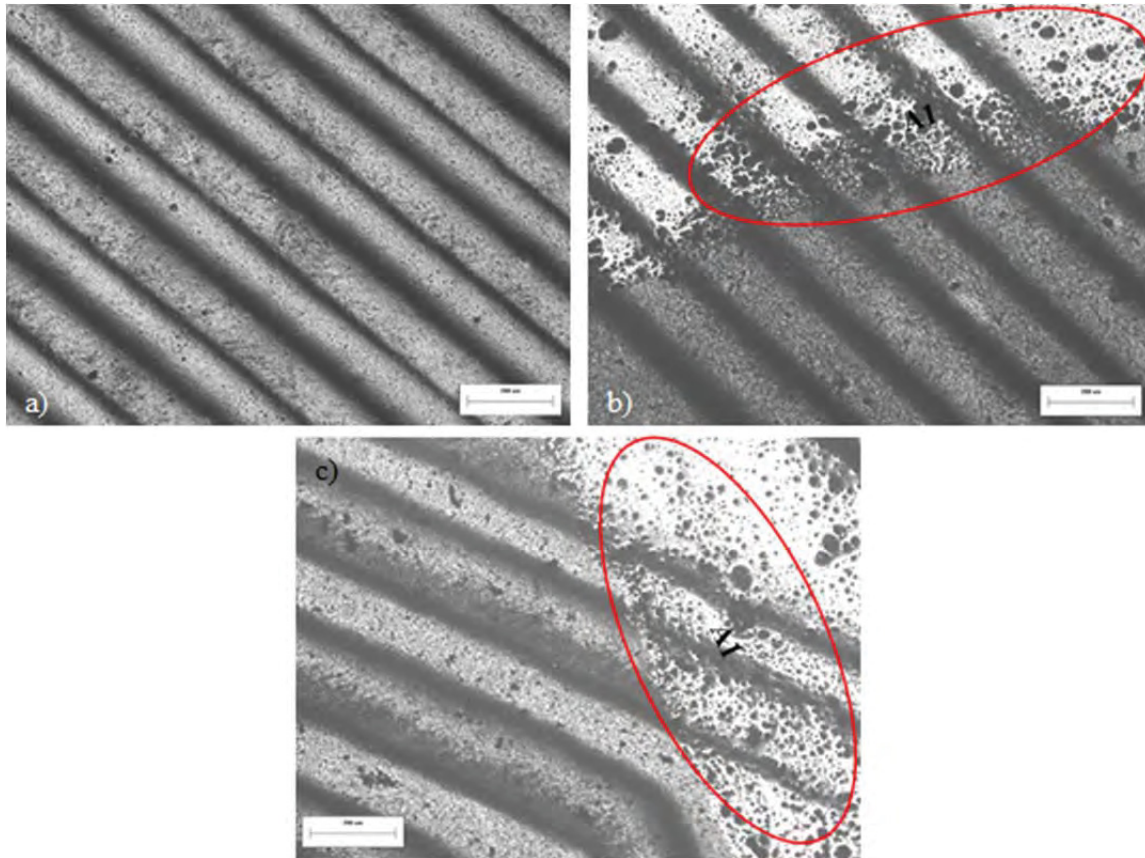
Figure 6-18: Conductive pathways on computer circuit board (50X magnification)
a) reference specimen b) three months after exposure to aerosol only c) two months after exposure to diesel fire with aerosol suppression

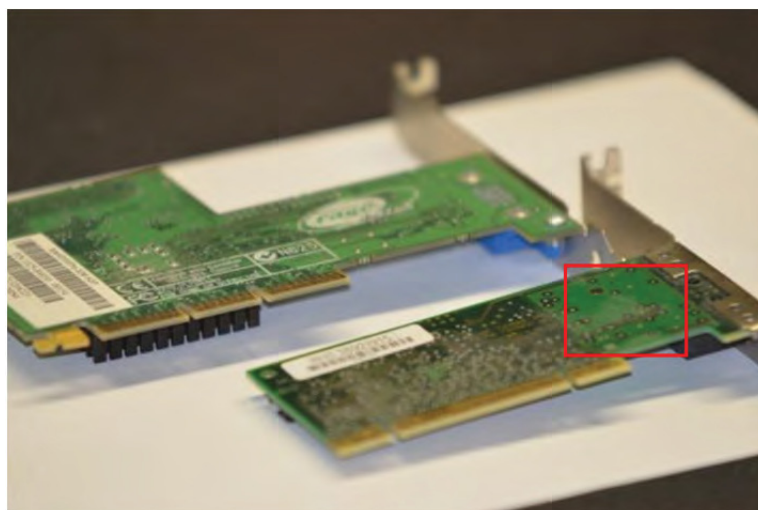
Figure 6-19: Computer card after six months after exposure to StatX aerosol agent

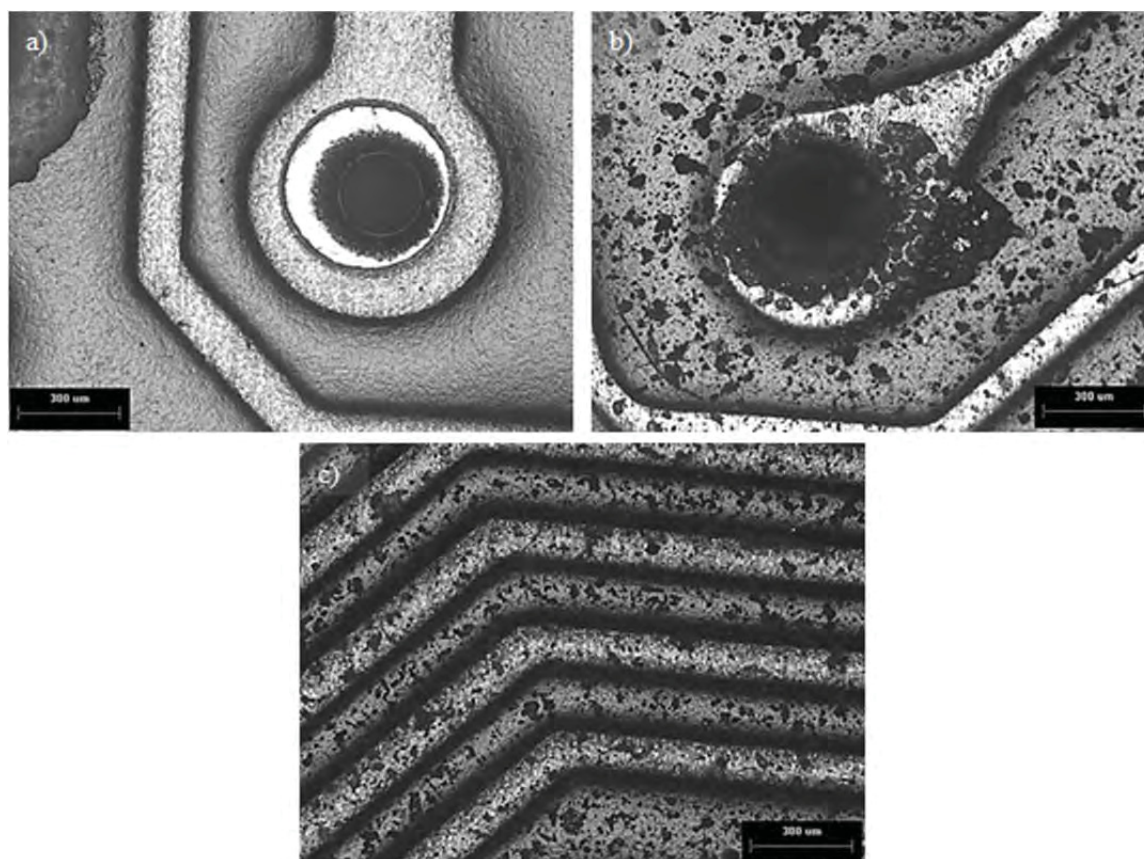
Figure 6-20: Connectors and conductive pathways on computer circuit board (50x magnification) a) reference specimen b) conductor six months after exposure to StatX aerosol only c) conductive pathway six months after exposure

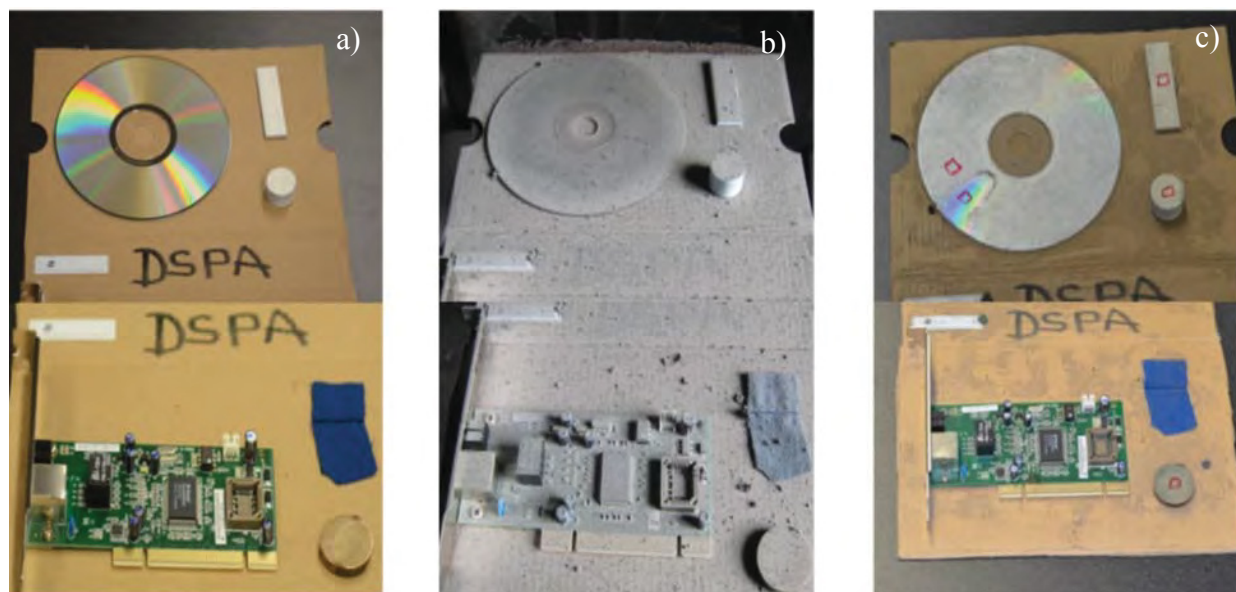
Figure 6-21: Nikon D7000 photographs of material samples used in DSPA 5-4 agent only test
a) reference specimens b) specimens immediately after exposure to aerosol
c) specimens one month after exposure to aerosol

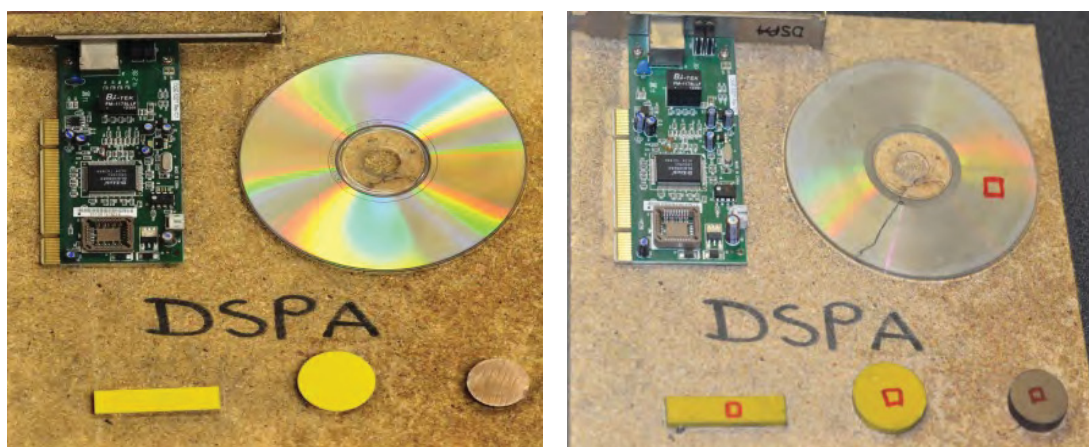
Figure 6-22: Nikon D7000 photographs of material samples in a DSPA 5-4 unobstructed fire suppression test a) reference specimens b) specimens one month after exposure to aerosol

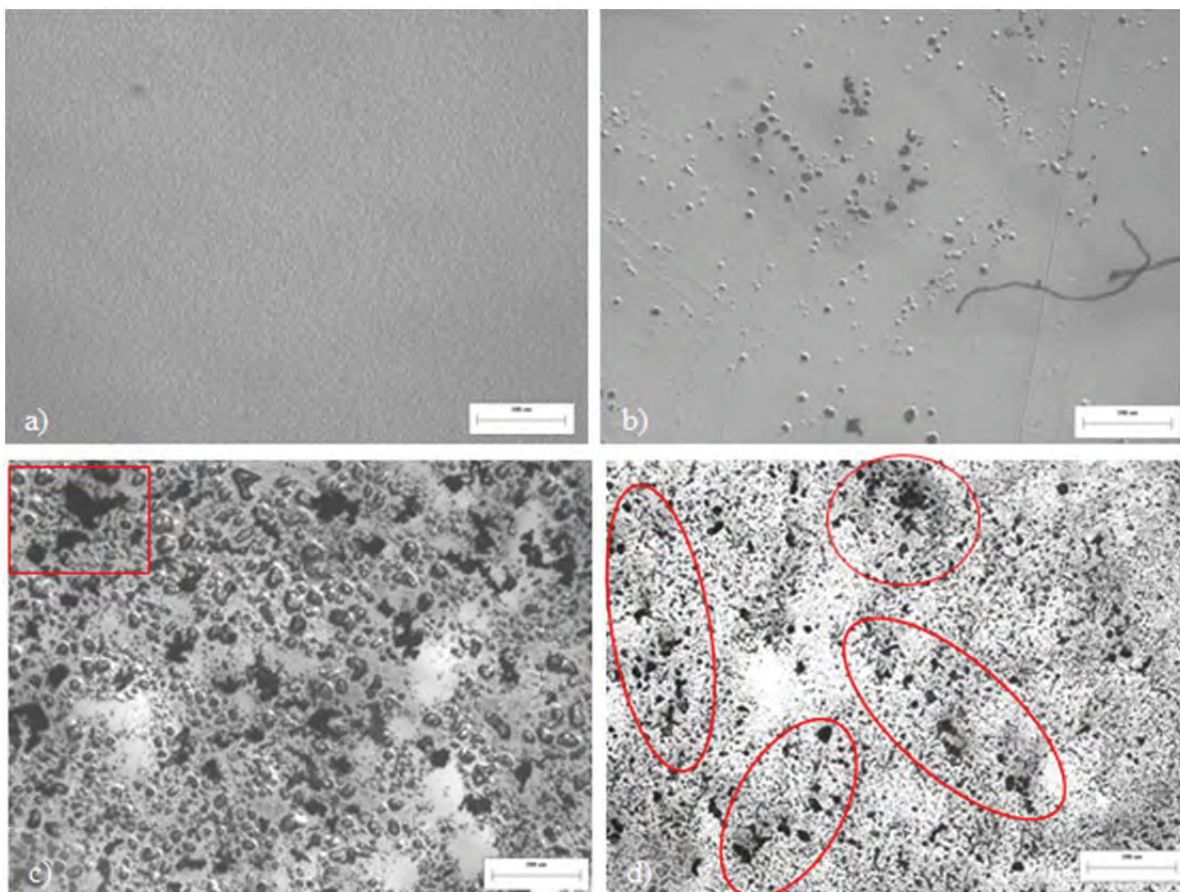
Figure 6-23: Surface of computer disc (50X magnification) a) reference specimen b) three months after exposure to DSPA 5-4 aerosol only (cleaned) c) three months after exposure to DSPA 5-4 aerosol only (uncleaned) and d) two months after exposure to diesel fire with DSPA 5-4 suppression
